DARTBROOK MINE

LANDSCAPE & LIGHTING MANAGEMENT PLAN

for Dartbrook Operations Pty Ltd

22 February 2024

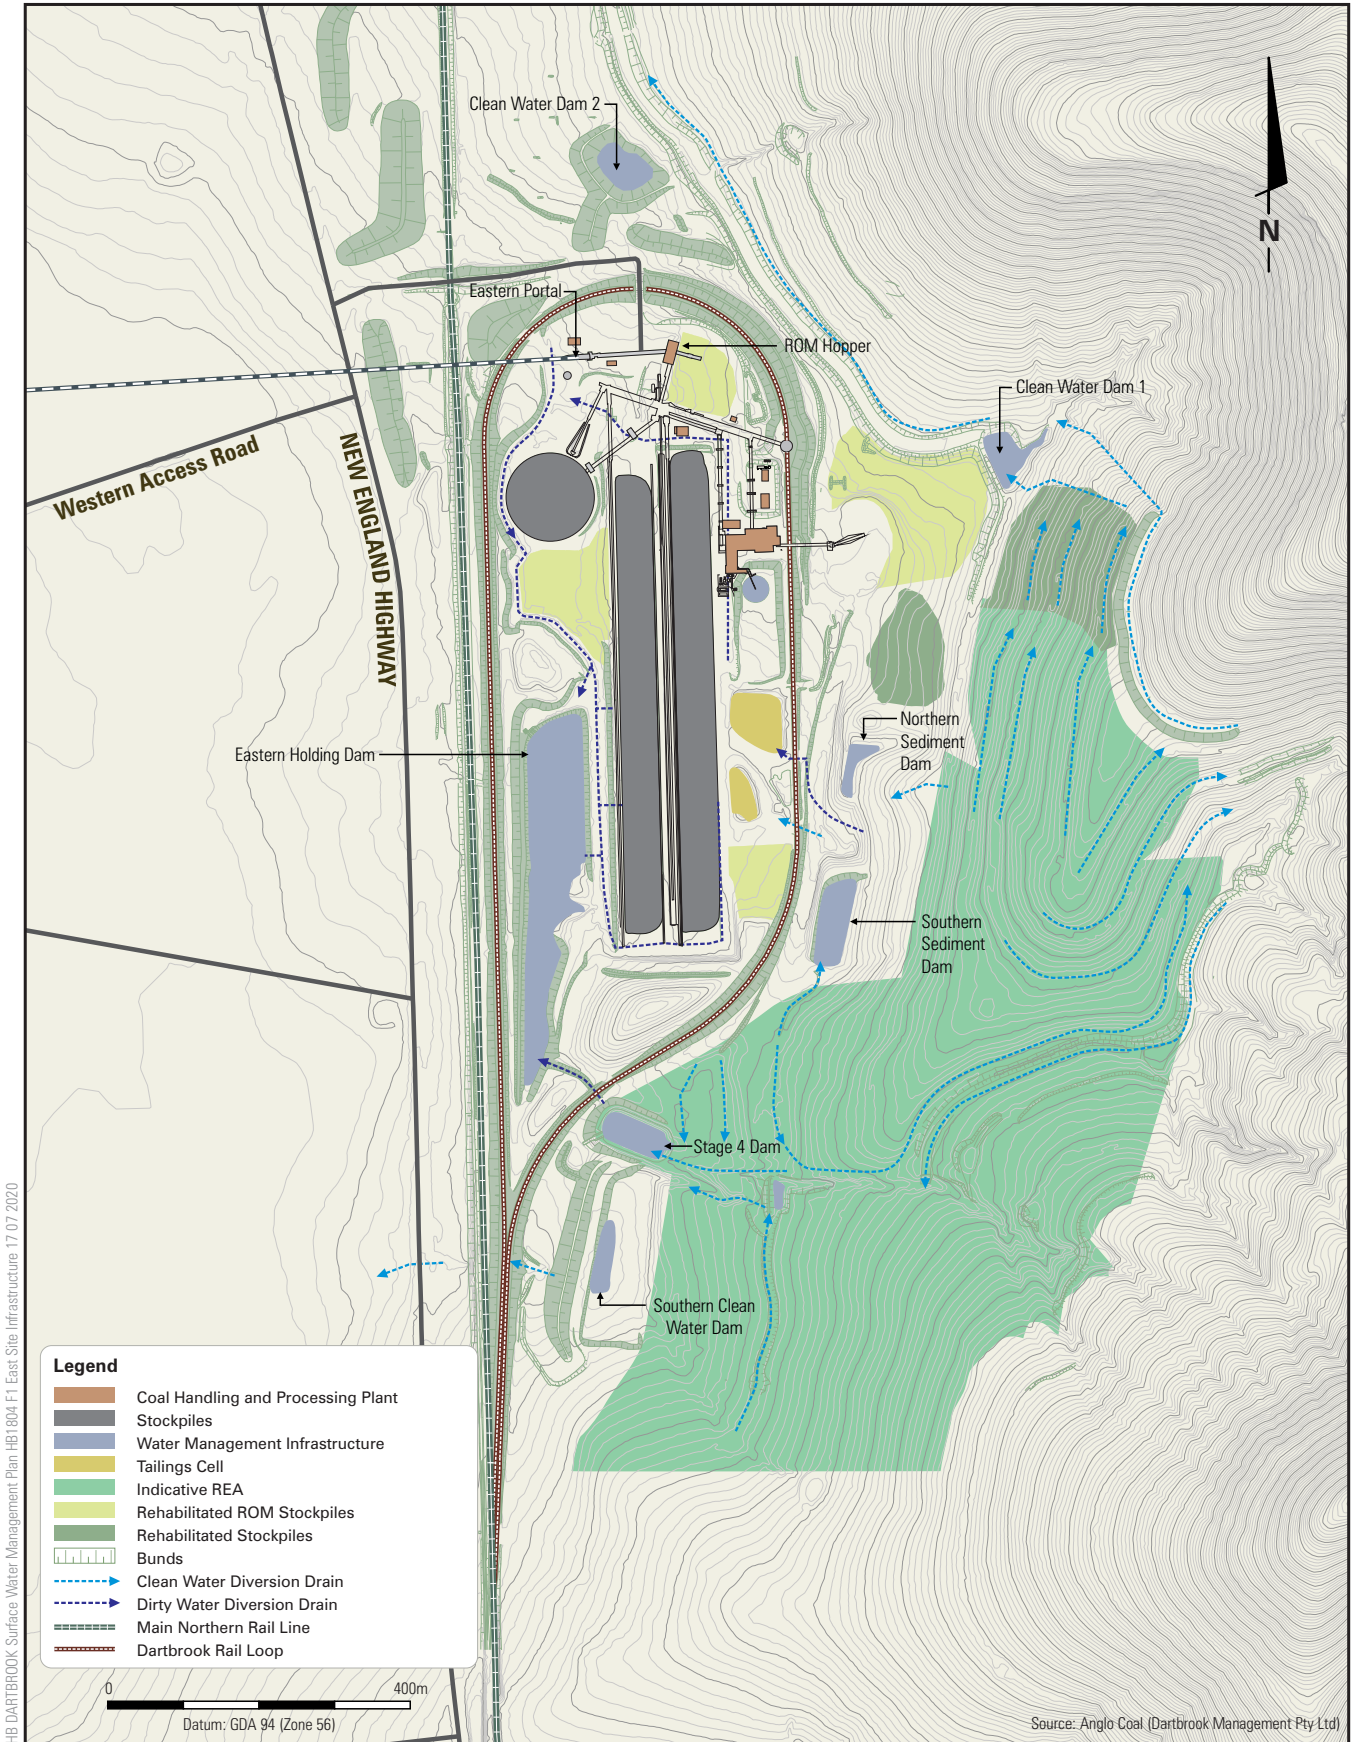
FIGURE 2

Dartbrook Mine Layout - East Site

Figure 2 and Figure 3 shows the location of these features of the Dartbrook. The location of nearby Visual Receptors in relation to Dartbrook is illustrated on Figure 4.

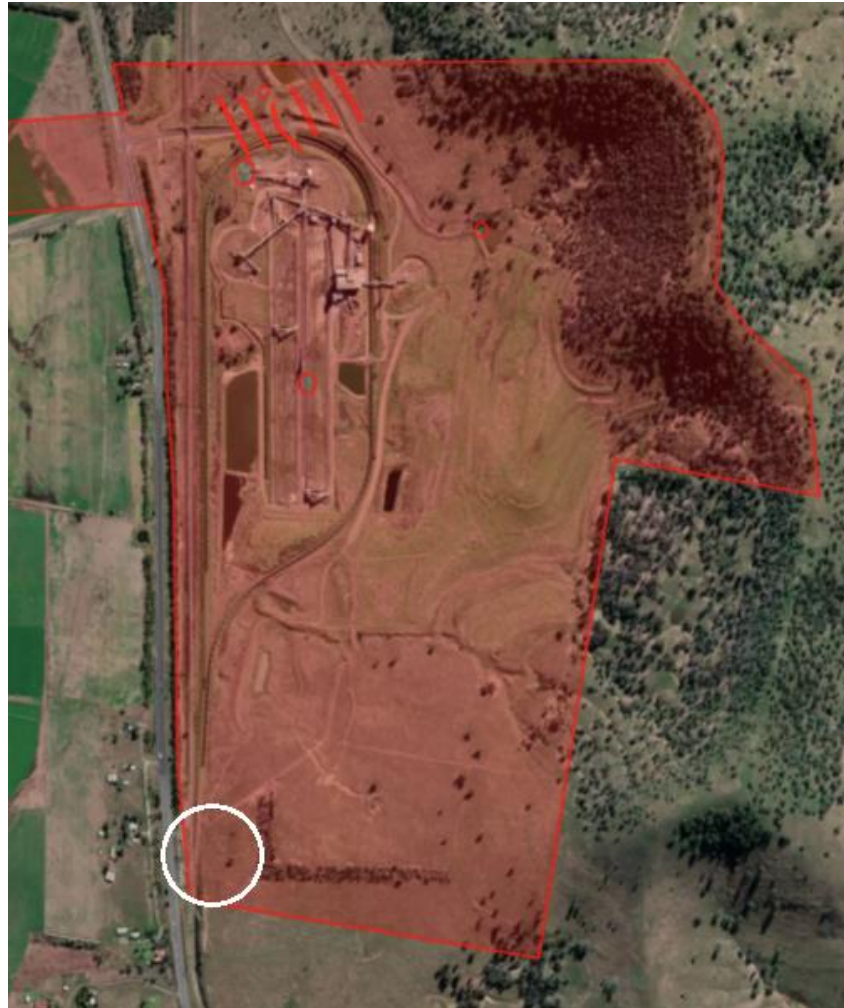
6	Consider plantings on the eastern side of the New England Highway to shield views for motorists heading north. Indicative location of recommended planting shown by white circle Figure 1 .

Figure 1: Recommended areas for consideration of additional plantings

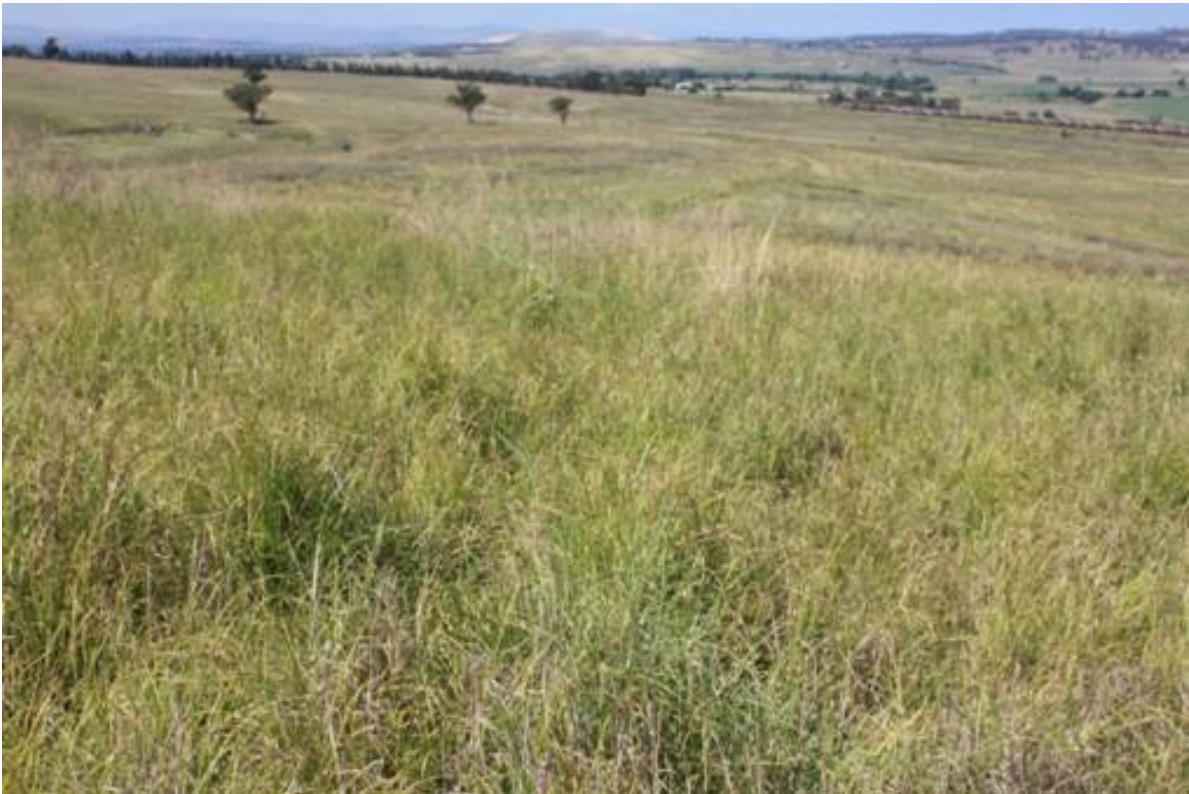
Plate 1 - REA rehabilitation 2010 - Western slope looking downhill to the southwest.

As a result of the suspension of mining operations in 2006/07, a number of areas became available for rehabilitation, including the REA. In 2006, 15 ha of the REA were rehabilitated with the remaining 9 ha rehabilitated in early 2007. Photos of the REA in 2011 are shown in **Plates 1 and 2**.

It can be seen from the photographs that the REA is completely rehabilitated with slopes and topography emulating slopes that occur in the surrounding landscape. Further it can be seen that for the grass cover emulates the surrounding grassland on adjoining low lands.

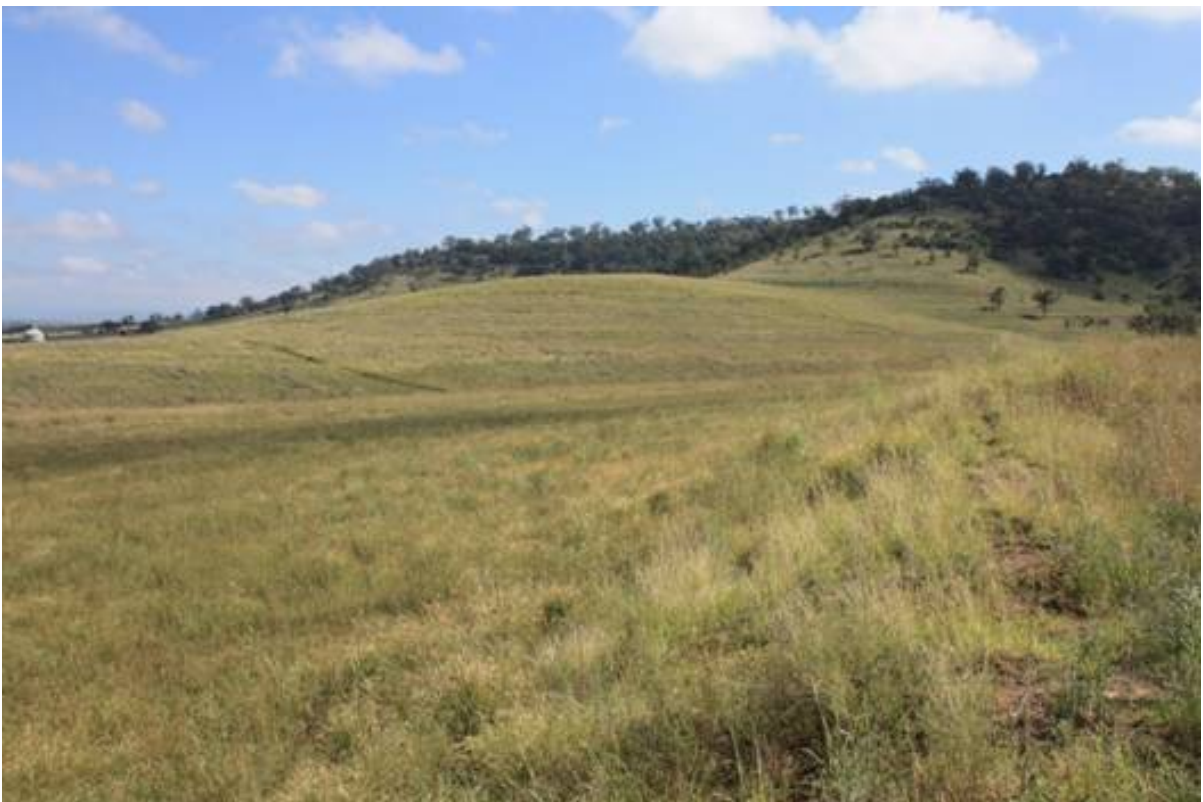
Plate 2 – REA rehabilitation 2010 - Western slope looking uphill to the northeast.

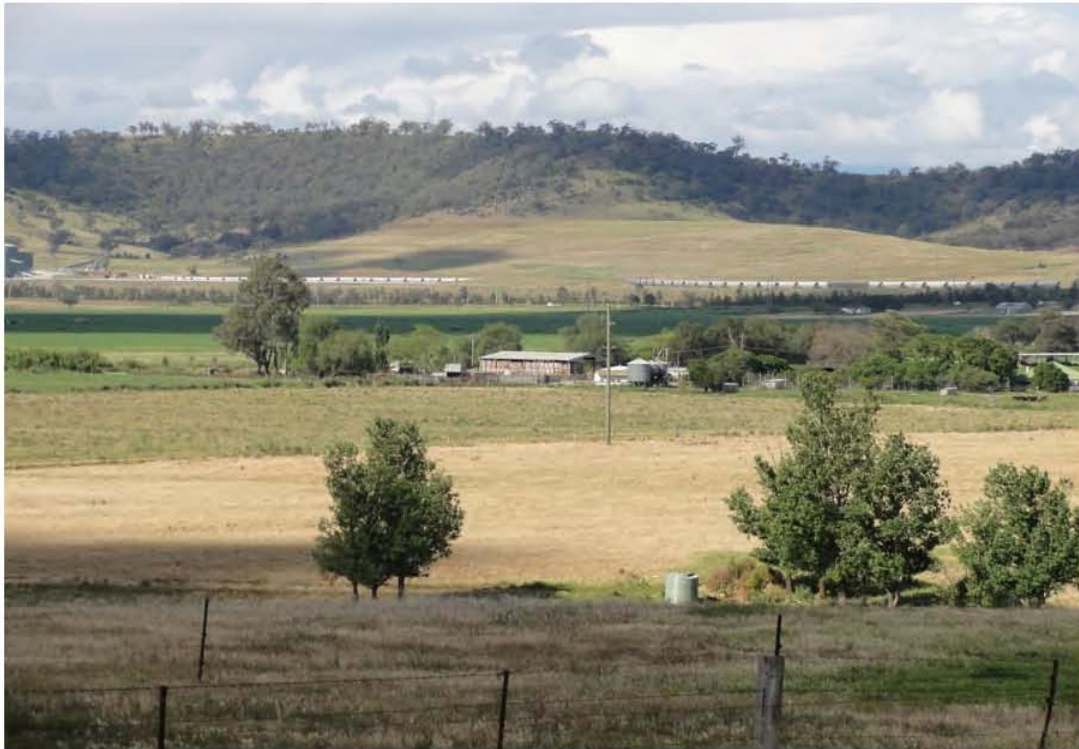
Figure 3a: The REA emulates the form and colour values of the existing landscape

In this way the REA emulates landform and vegetation and creates a low visual effect.

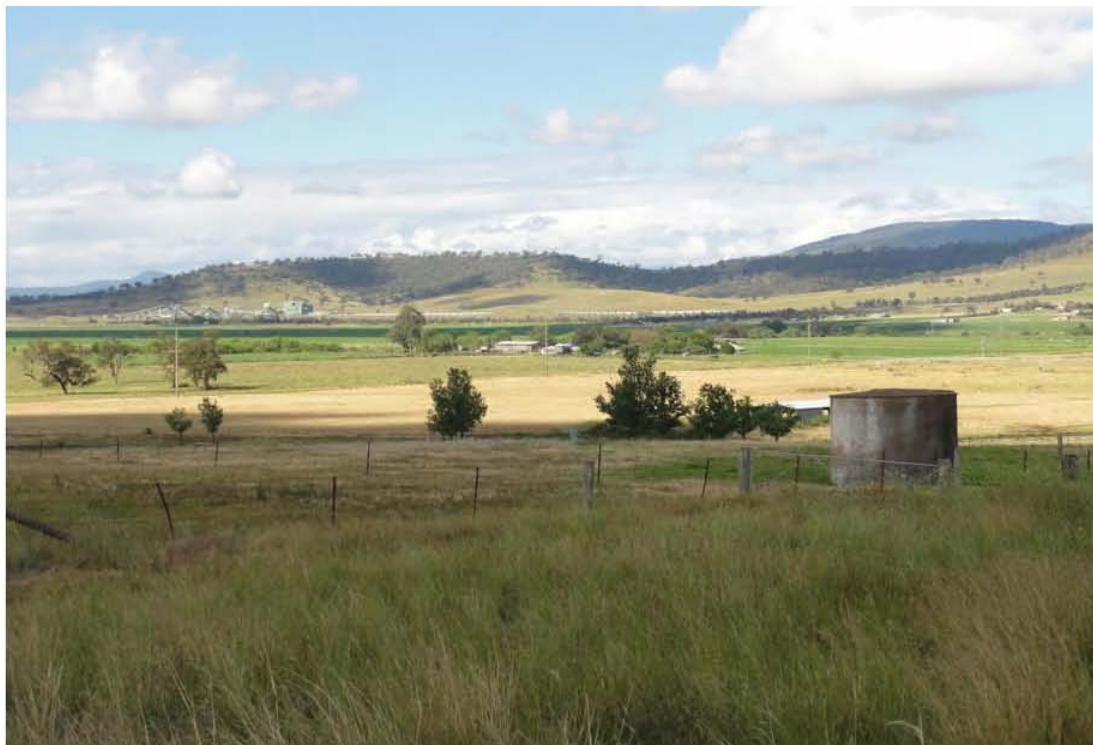
Figure 3b: illustrates how well the rehabilitated REA integrates with the surrounding land forms and land cover.

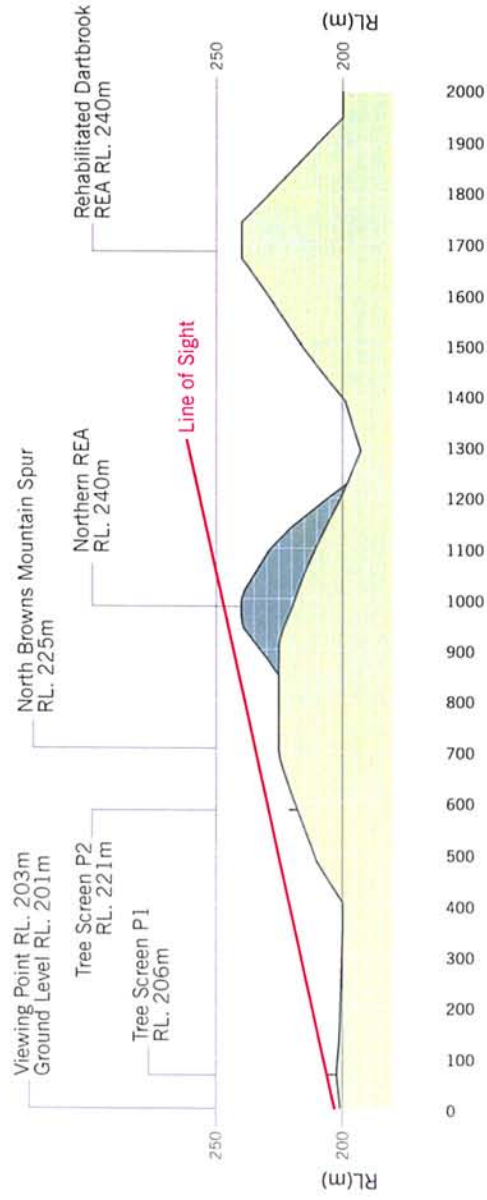
Note: These Sections have 250% vertical exaggeration for presentation purposes and do not represent the actual vertical scale of the REA

Southern Viewing Location
Line of Sight Section
